NHDOT SPR2 PROGRAM

RESEARCH PROGRESS REPORT

| Project Title: Evaluation of Gusset-less Truss Connection to Aid Bridge Inspection and Condition Assessment | | |

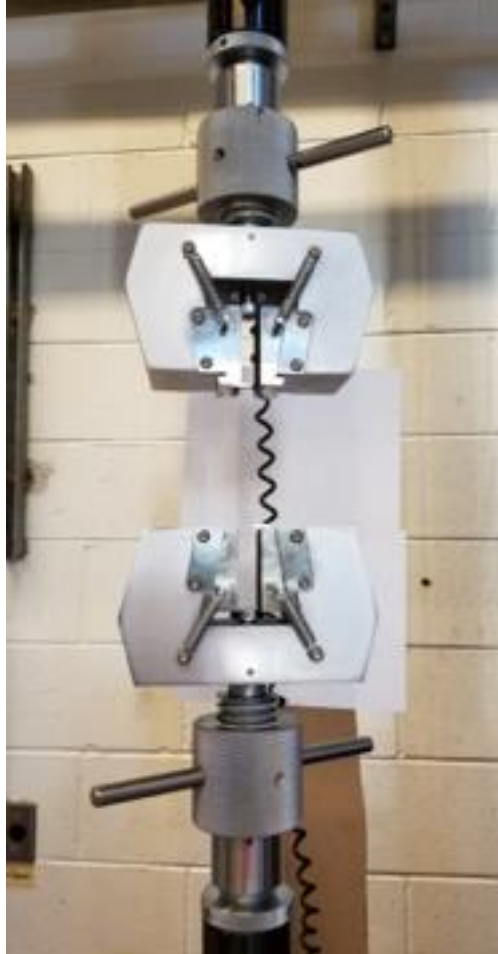
Figure 1: Original grips installed at the Instron Machine

During the second quarter of 2017, weld specimens with and without defects were fabricated to evaluate the fatigue performance of intact and defective 7/16" welds. As part of this effort, a mock test was performed. Due to limitations of the testing machine, significant slippage was present during the cyclic test and an alternative testing approach was designed. The Civil and Environmental Engineering Department procured grips to be attached to the Instron Universal Testing Machine at the UNH Structural Engineering Laboratory (Figure 1). The advantage of using the aforementioned grips is twofold: (i) the grips prevents any slippage in the response once the specimens are exposed to cyclic loading, and (ii) time and resources are saved given that specimens do not need to be machined to a circular cross-section and specimens with square cross-sections can be tested without modifications. Figure 2 shows one of the specimens to be tested. The only machining necessary involved reducing the cross-section in the middle of the specimen (where the weld is located) in order to induce fatigue failure at this location. The grips arrived toward the end of the third quarter and testing in October and November demonstrated that they were defective. Material Testing Technology (MTT) were contacted, and after a few weeks going back and forth with them, the original grips were returned and a new set of grips were sent to us at the beginning of December. Thus, testing of the weld specimens is now schedule for the first quarter of 2018. Fortunately, this testing can be done in parallel with testing of the small-scale specimens of the gusset-less connection.

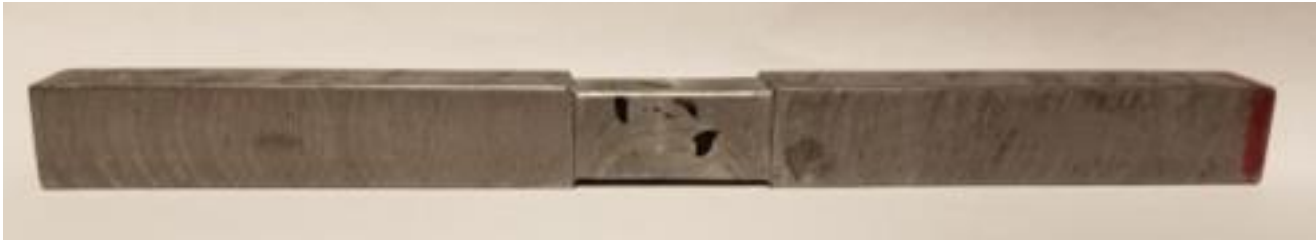
Figure 2: Example weld specimen

Due to the focus on the fatigue testing in the small-scale connection during this quarter, the testing on the weld specimen was not performed in the first quarter of 2018 and it is planned to happen in the beginning of the next quarter. The grips from Material Testing Technology (MTT) are still available for the test.

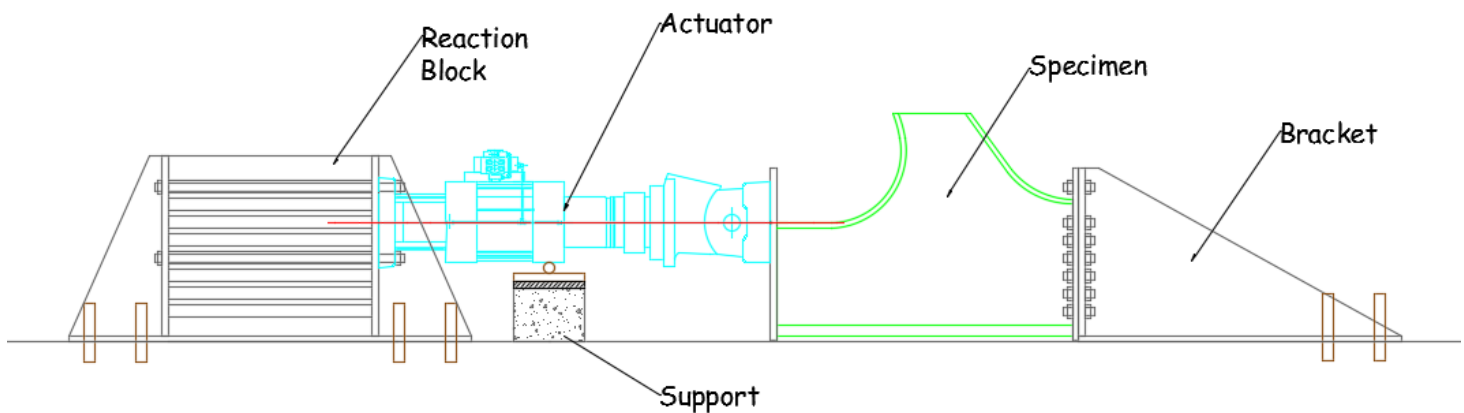
Figure 3: Schematic of setup for fatigue testing

In the beginning of this quarter, the support components of the test setup were delivered. Figure 3 is a drawing of the setup. Moreover, a vertical support for the actuator was designed. The goal of this support is to hold part of the actuator's weight and, on top of the support there is a roller, which only carries vertical load, still allowing movement in the horizontal direction. This mentioned support also has neoprene in between the roller and the block to isolate any frictional effects. Figure 4 shows pictures of the reaction block and bracket.

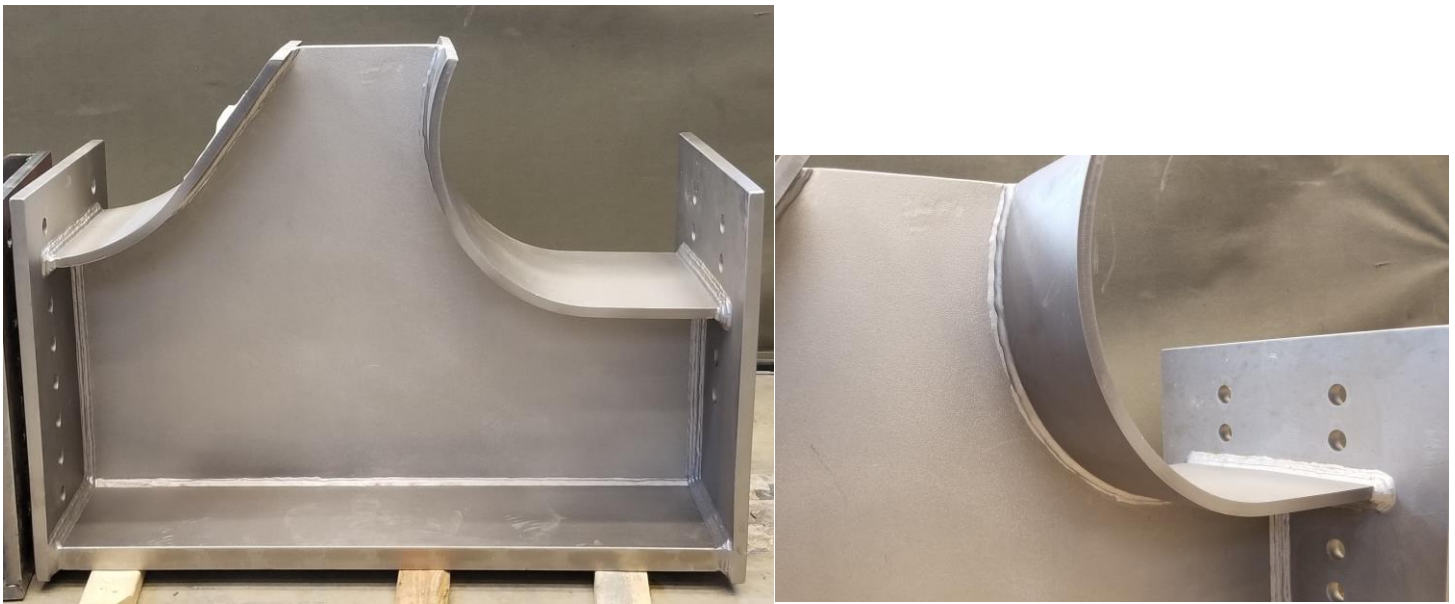
Figure 5: Specimen

In February, the two specimens were delivered from CANAM Bridges. Figure 5 shows pictures of the first specimen to be tested. The specimens were sand blasted prior from shipping.

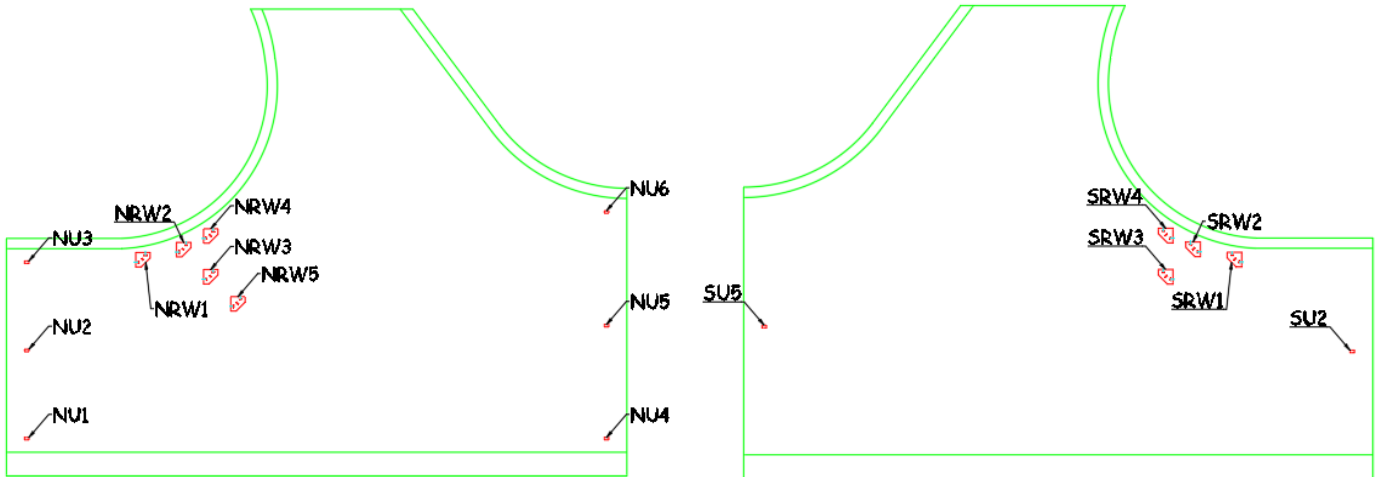
Figure 6: Gages instrumentation north (left) and south (right) side of the specimen

During this quarter, the instrumentation plan was defined and the material ordered. The first decision was to use the same strain rosettes specifications that the Memorial Bridge is instrumented. From a rosette, strain is collected from all directions, allowing to calculate principal strains in the location where it is bonded and then apply equations to convert to principal stresses. It is important to have the principal stresses at the area under the curvature to compare with the maximum principal stresses due to fatigue provided by HNTB Corporation in their Summary Calculation. This strain rosette is spot welded to the surface, and the company that sells it, Hitec Products, provided instructions and training for the graduate student for the proper installation of the rosettes. In addition, uniaxial strain gages are installed at the specimen close to the supports to verify boundaries conditions. Figure 6 shows the locations of the strain rosettes and uniaxial gages in both sides of the specimen.

In addition to the strain gages shown in Figure 6, Digital Image Correlation (DIC) will be utilized as a non-contact measurement method. DIC is a measurement method that identifies groups of pixels, called subsets, and tracks the movement of those subsets across multiple images. The tracking is calculating the displacement vectors of the subsets and using them to calculate displacement and strain with relation to a reference image. This method can be used for both two- and three-dimensional measurements of the strains and displacements of the surface of the specimen. The advantage to DIC as a measurement tool is that it provides measurements across the entire surface that is captured by

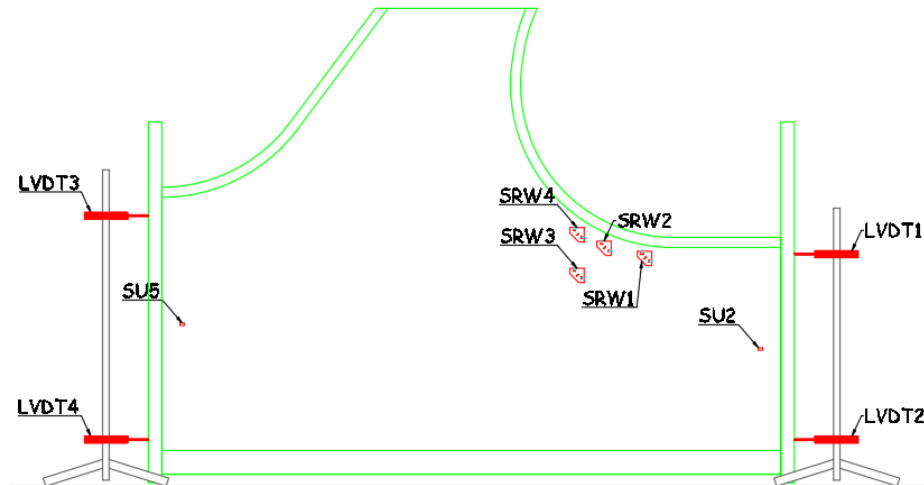
Figure 7: Illustration of LVDTs locations

As part of the instrumentation, LVDTs will be placed at the plates located at each end of the specimen. The LVDTs are held by clamps which use a steel stand to adjust their height. Having the LVDTs at those specified locations will provide information of any rotation of the plates, which is important for the data analysis and model verification. In addition, the pipes of the reaction block are instrumented with uniaxial strain gages.

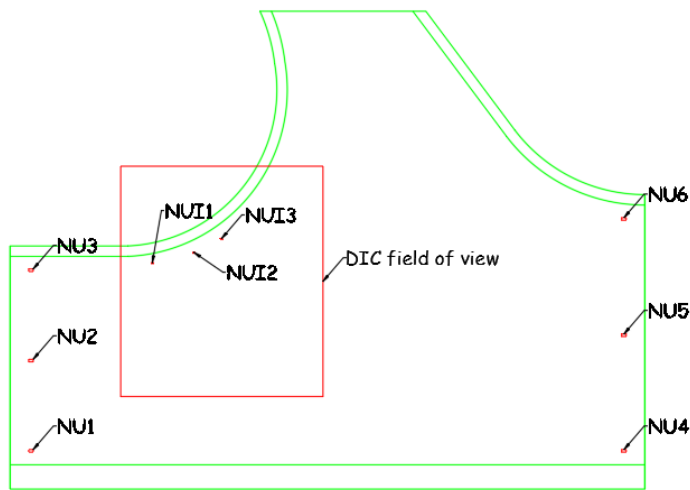
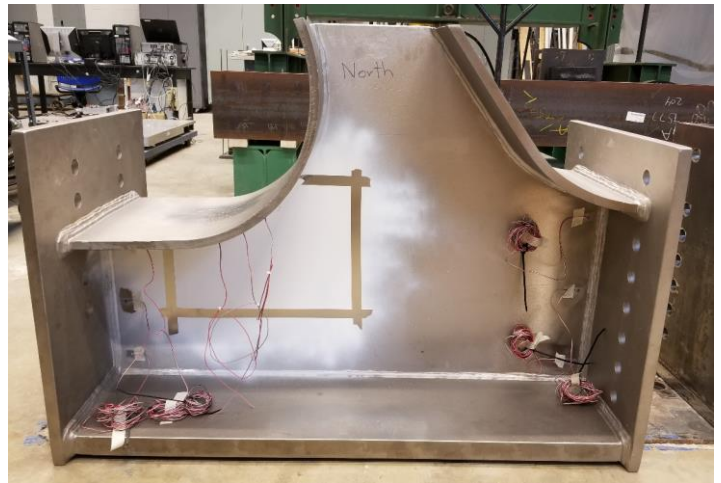
Figure 8: Instrumentation for initial test

In this test, both two- and three-dimensional DIC will be used for different reasons. The two-dimensional DIC will be used to capture strains and displacements in the web of the connection during an initial static-loading test. Figure 8 shows a picture of the instrumentation for the initial test. The goal of this initial test is to use DIC to identify the strain contours of the specimen given the applied load which should match with the strain contours provided by HNTB Corporation, as well as the strain contours from the finite element model (FEM) of the connection. These measurements will be compared to the strain gages in NUI1, NUI2 and NUI3 (Figure 8) to verify that the measurements are accurate. If the measurements match those of the gages, there will be confidence in the DIC measurements and the strain contours identified from this test. These contours will be used to finalize the locations at which the strain rosettes will be placed for the fatigue test.

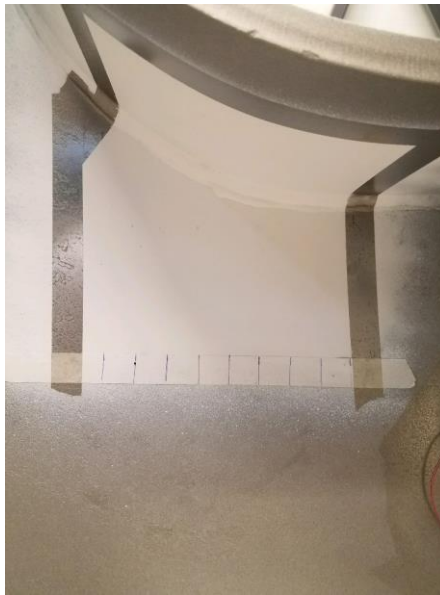
Figure 9: Web to flange DIC field of view

The three-dimensional DIC will be used for the full-scale fatigue test to capture a unique area-of-interest. The area-of-interest will be focused on the interaction between the web and the underside of the top flange, depicted in Figure 9. Due to the geometric constraints, and not wanting to damage the weld with surface preparation, strain gages cannot be placed on or particularly close to the weld. Using three-dimensional DIC in this area will characterize the behavior, through displacement and strain measurements, of the web and flange as well as the weld.

As a note, the areas shown as field of view are still not ready for testing. A speckle pattern will be done with a special speckle roll, which will create the contrast in the images captured by the cameras.

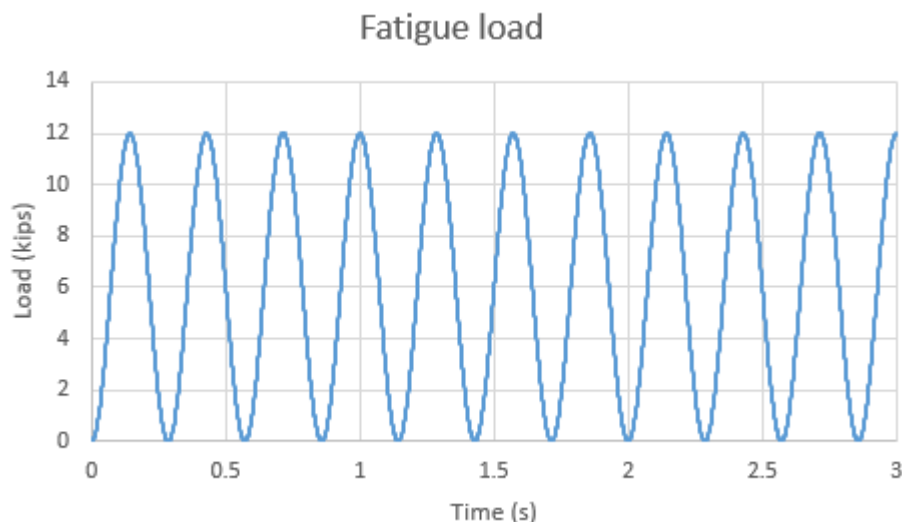
Figure 10: Fatigue load protocol example

As mentioned in previous reports, the fatigue test are consist in cyclic tests, initializing at the design load stress, followed by the allowable stress from the fatigue category of the weld and then extrapolated until failure happens and/or the capacity of the actuator is reached. The frequency of the test was decided in 3.5 Hz only in tension. Figure 10 is a fatigue load protocol example for 3 seconds of test. The 12 kips load shown in the figure is the load necessary to achieved the expected design stresses in the weld under the curvature.
